WEAR - Typical Patterns

PREMATURE WEAR - Material Flow / Loading Issues

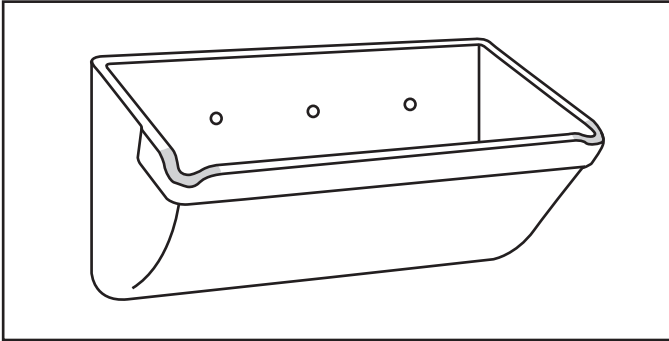
STAGE 1. Corners show minor wear, capacity close to 100%

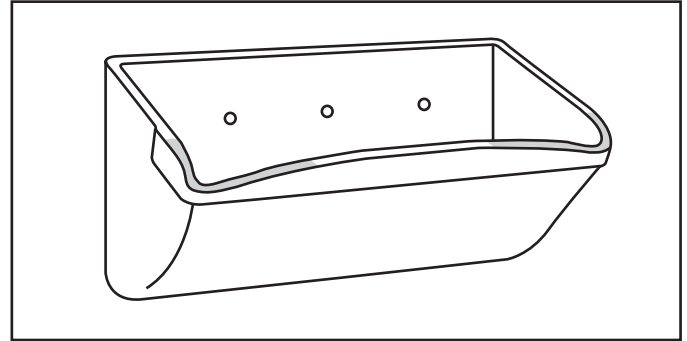
STAGE 2. Corners show more wear, capacity reduced to 90-95%

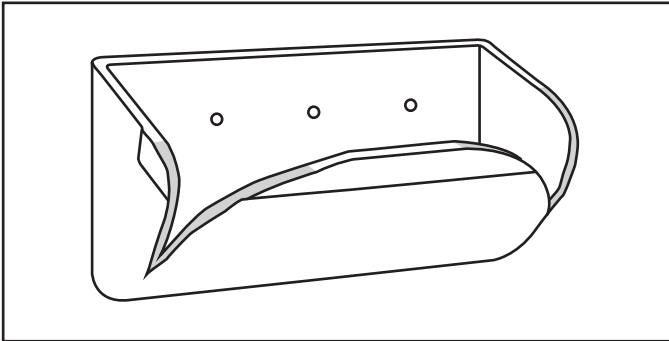
STAGE 3. Corners worn out, may discharge erratically, bucket losing significant capacity

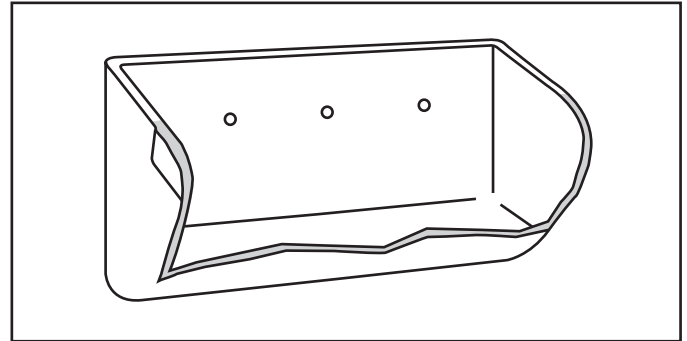
STAGE 4. Front of bucket has broken off

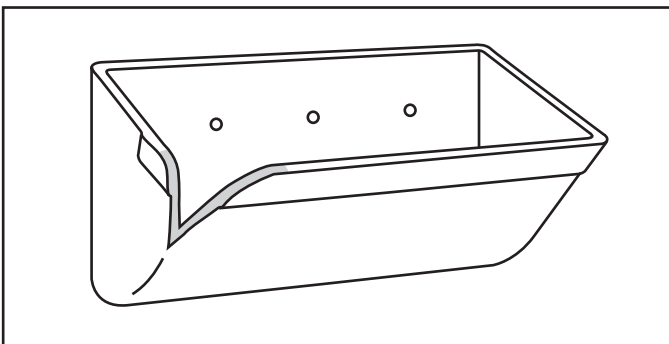
Uneven Wear - Corner

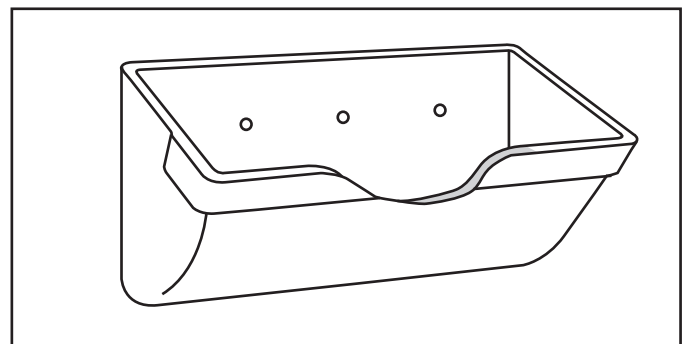
Uneven Wear - Middle

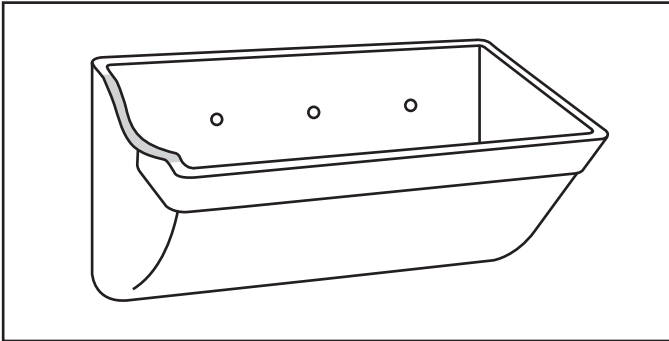
Uneven Wear - Side

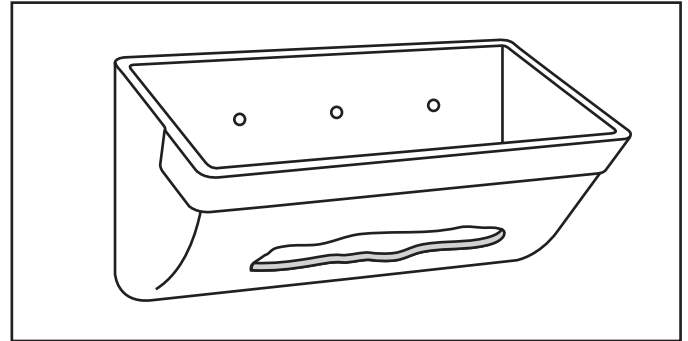
Bottom Wear - Hole in bottom of bucket,
loading at a poor angle

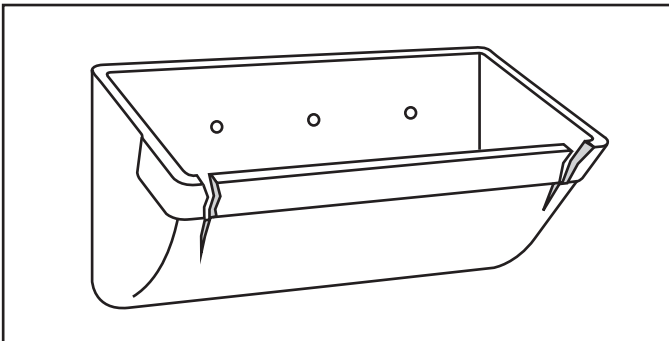
Front Corner Cracking - Excessive digging
impact

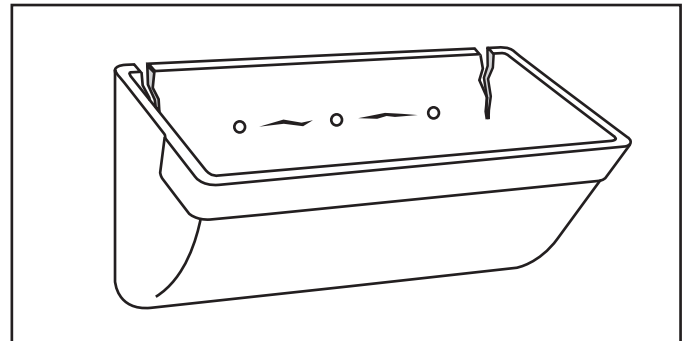
Back Corner Cracking - Excessive crown on
head pulley, impact on front lip,
or excessive torque on bolts

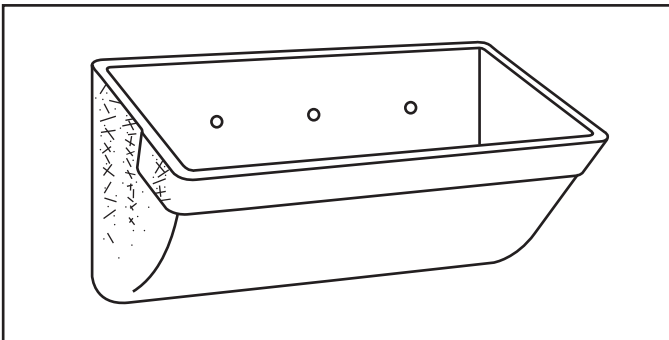
Bucket rubbing on casing of elevator
causing marks on side of bucket

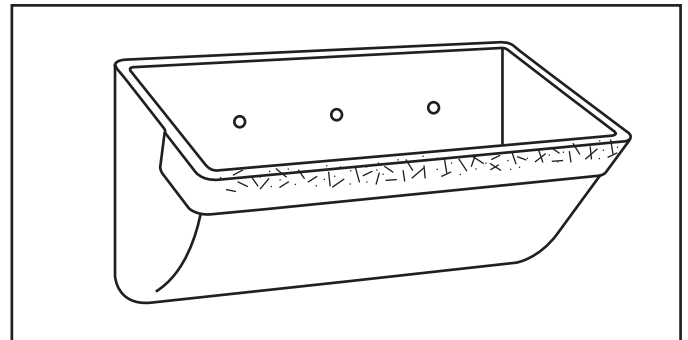
Bucket rubbing on casing or bottom of
boot causing marks on front of bucket
