# Two-Year Rebuild

### ALL POINTS COOP ELEVATOR BACK IN OPERATION AFTER 2008 EXPLOSION

#### All Points Cooperative Gothenburg, NE • 308-537-7141

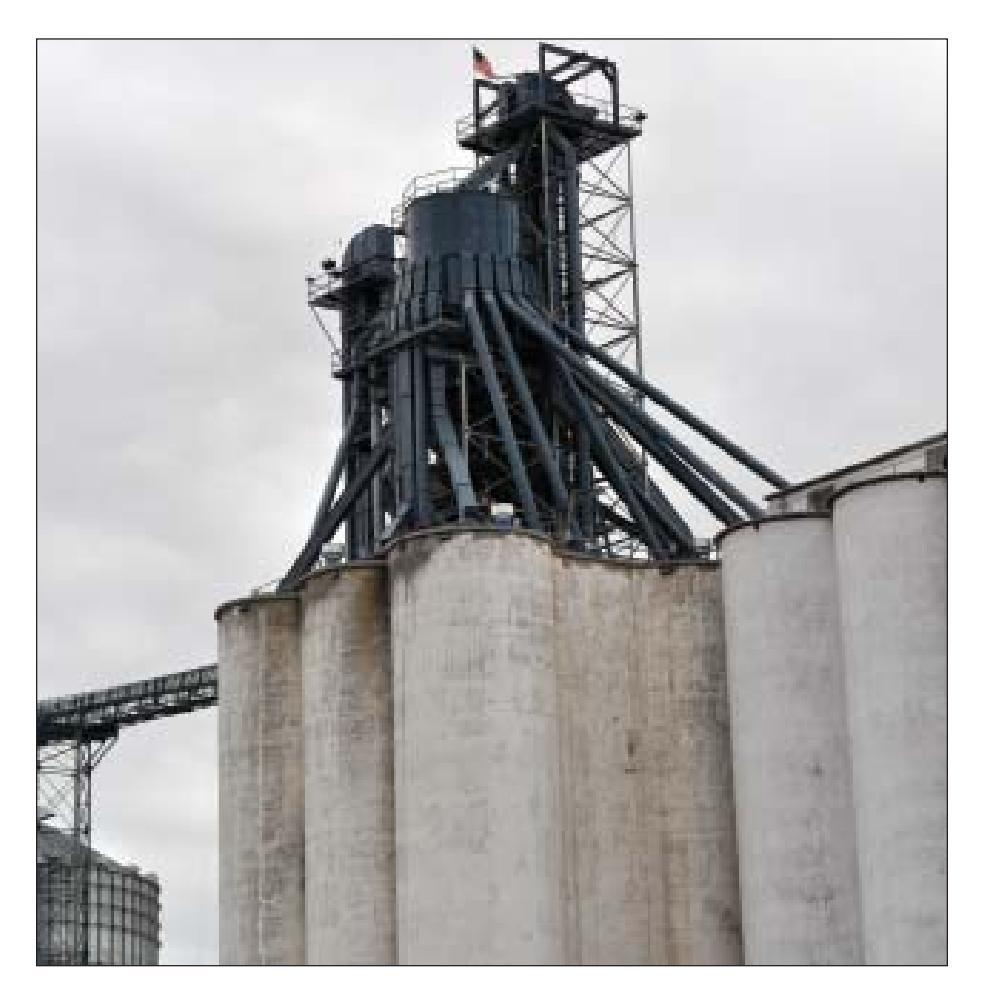
New leg head sections, double distributor, and screener now are located on the outside of the slipform concrete workhouse.

• Replacement of two inside legs with 20,000-bph Hayes & Stolz legs outfitted with a single row of 20x8 Maxi-Lift CC-MAX buckets on a 22inch Goodyear belt. The head sections of the legs now terminate in an outside steel frame structure.

• Installed a 26-hole, 24-inch-duct Hayes & Stolz double distributor in the rooftop complex.

• Installed a 20,000-bph Texas Shaker cleaner, outfitted with an optional hinged sidewall for easy screen changes.

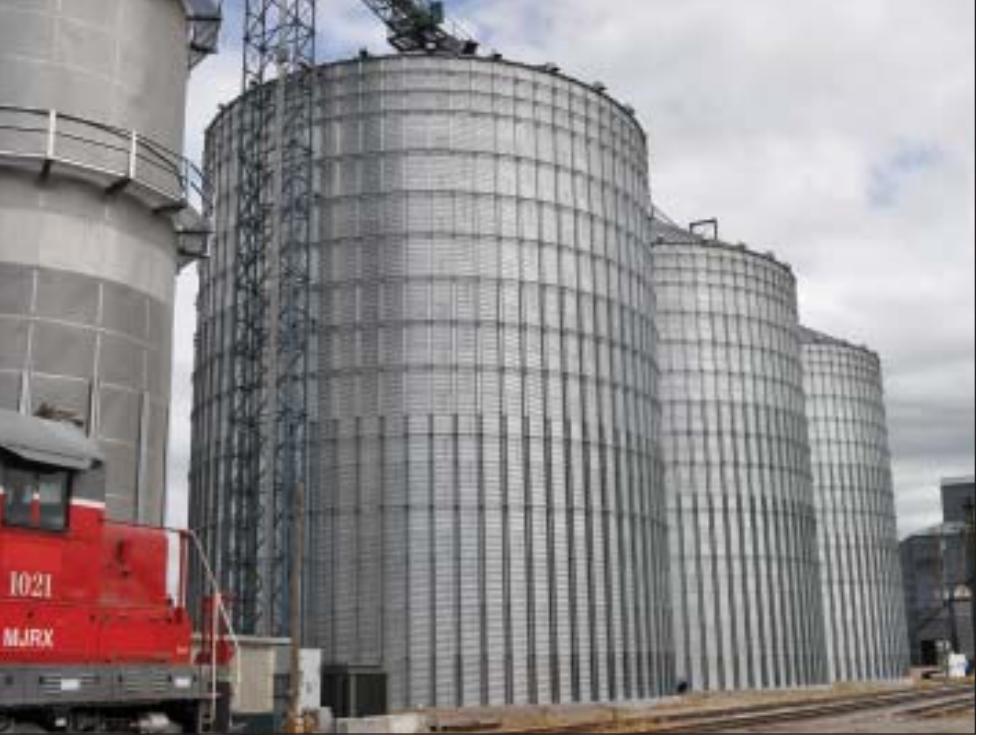
Three Behlen tanks make up a 1.2-million-bushel steel annex that was completed just prior to a Nov. 19, 2008 explosion.

The annex, intended to hold grain for loading onto Union Pacific shuttle trains, included three 420,000-bushel Behlen steel tanks, a new receiving pit and outside leg, and a 7,500-bph GSI grain dryer.

The three tanks stand approximately 79 feet in diameter, 95 feet tall at the eaves, and 117 feet tall at the peaks. The flat bottom tanks are outfitted with outside stiffeners, 12-inch GSI sweep augers, 10-cable

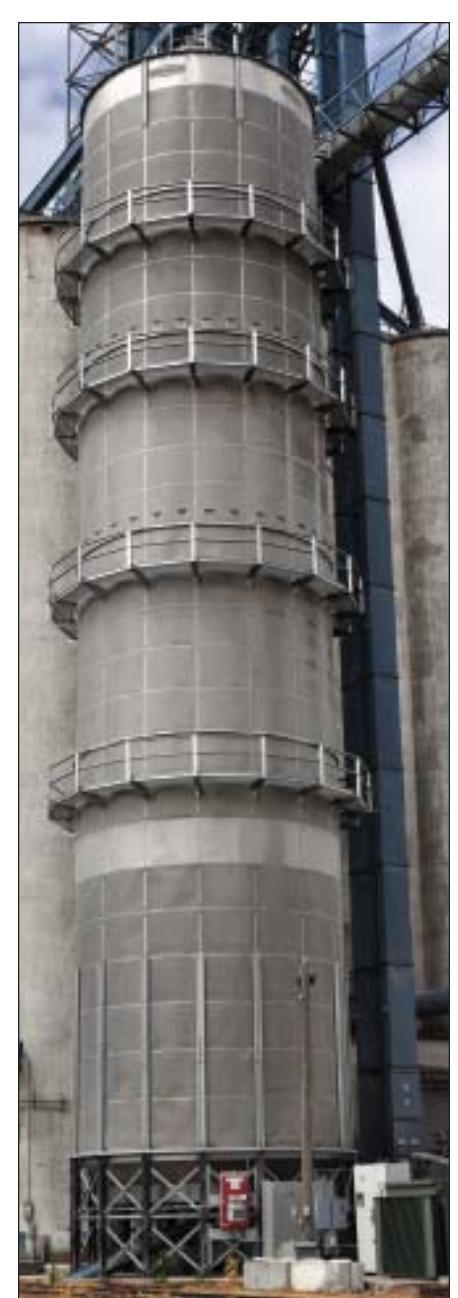
Relatively new 7,000-bph Brock naturalgas-fired grain dryer was built as part of the steel annex project.

The 7,000-bph Brock dryer is fired by natural gas and has received a thorough workout since it was constructed in 2008. It is empties into a 10,000-bph Intersystems wet leg.
